Historic Un-stabilized

Adobe Training

San Diego County Parks

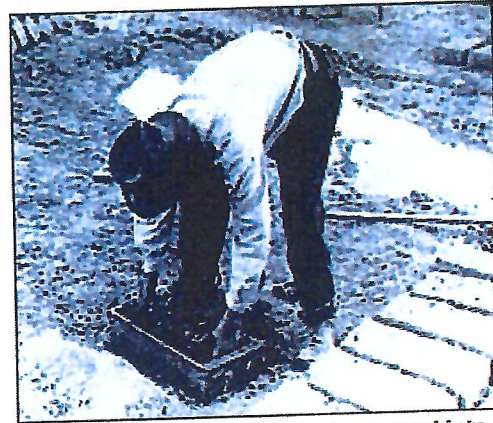
A mixture of mud and straw is pressed into a mold to form an adobe brick. After the adobe brick is removed from the mold, it must dry in the open air for a month or more before it can be used. Photo: Russell Lee, Farm Security Administration Collection, Library of Congress.

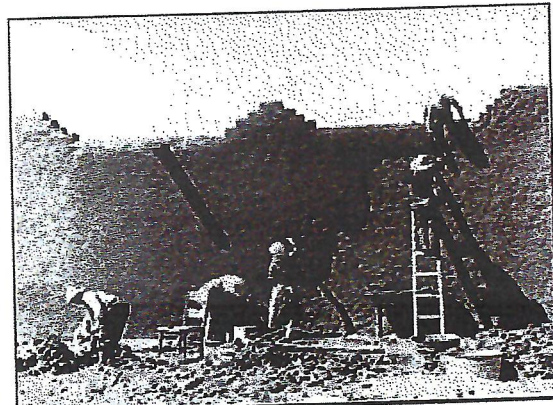
Traditionally, adobe surface coatings that protected the fragile adobe building fabric were renewed every few years. Women are seen here recoating an adobe wall with mud plaster mixed with straw at Chamisal, New Mexico. Photo: Russell Lee, Farm Security Administration Collection, Library of Congress.

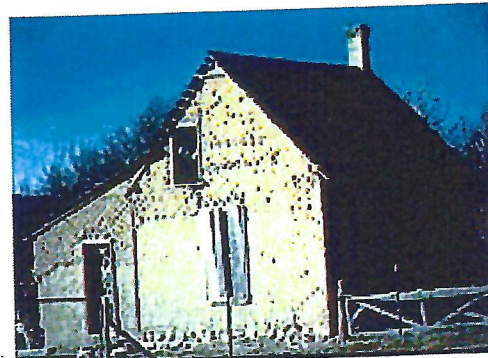
A traditional mixture of mud and straw plaster should be applied to stabilize the exterior of this house. Photo: NPS files.
