ARCHAEOLOGICAL MANIFESTATIONS OF A MECHANICAL ADOBE MANUFACTURING SITE NEAR ESCONDIDO, CALIFORNIA, 1947-1975

MICHAEL BUXTON, KASSANDRA NEARN, AND MICHAEL TAYLOR
NWB ENVIRONMENTAL SERVICES, LLC, SAN DIEGO, CALIFORNIA

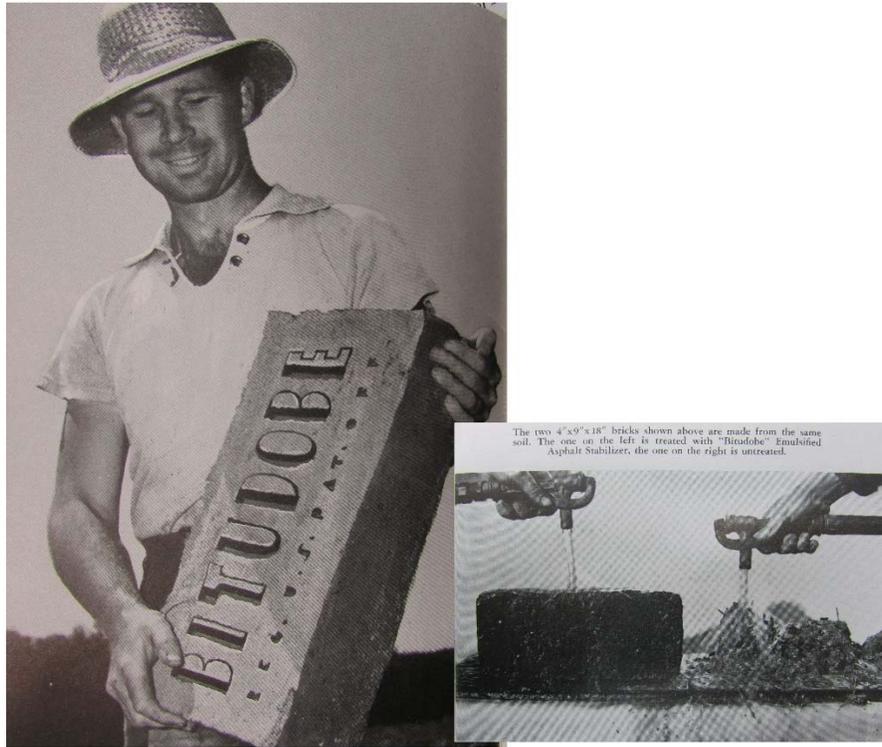
Figure 2. Bitudobe was the first effective soil additive (American Bitumuls Company, 1943).

Ultimately, plastering surfaces and early additives did little to protect the adobe from moisture, calling for further innovation in later years. Emulsified asphalt was invented in 1924, and it became the first effective adobe soil additive as an emulsion of oil and water. When added to soil, the additive covered the soil particles with a protective film, stabilizing the adobe brick. Bitudobe Emulsified Asphalt Stabilizer was licensed by the American Bitumuls Company in 1937 and received approval from the Federal Housing Administration (FHA) for use as a building material (Figure 2). Government building standards helped increase its use by providing specific requirements for building materials that fit Bitudobe's characteristics. The product was strictly licensed, and soil samples were sent to company laboratories for testing. The company would determine the correct amount of additive to be used as a standard in the adobe manufacturing process (American Bitumuls Co 1946:29; Comstock 1948:30).

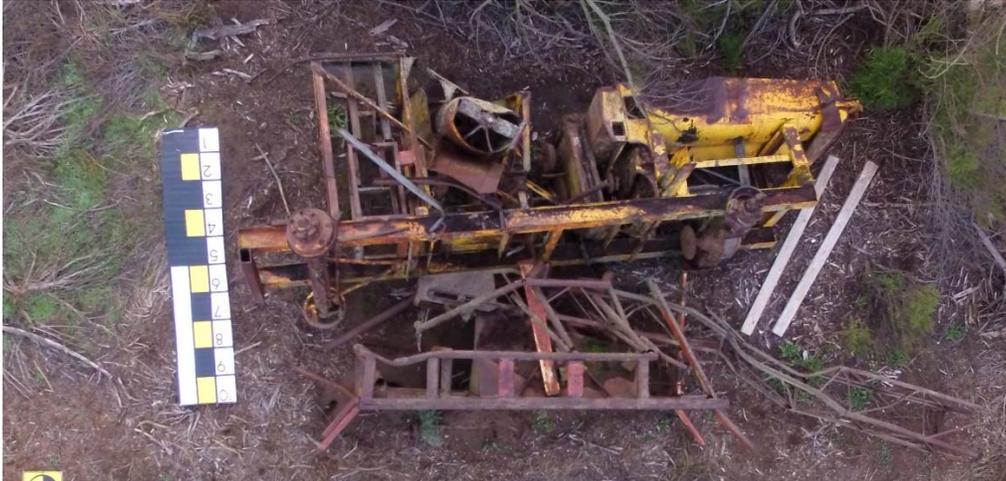
Figure 3. Aerial image of Feature 1 (scale in feet).

Feature 1 is located at Locus A on the east side of the site and consists of machinery remnants from a mechanical adobe mixer (Figure 3). Parts of the mixer are attached to a metal chassis, with additional machine remnants present on the chassis. The metal chassis is comprised of two steel I beams; other attached parts include wheel hubs, axles, a transmission case, and other miscellaneous parts. A 12-ft-long metal mixing bucket is attached to one end of the chassis. Paddlewheels attached to a shaft are present inside the bucket (Figure 4). Gears that were used to turn the shafts, sheet metal, wood, and other parts are also present. Remnants of a conveyor belt are present, consisting of a metal frame constructed with 1 1/2 in. angle iron. Rollers are attached to the conveyor belt frame (Figure 5). The metal conveyor frame is jammed between the metal chassis and a separate, large metal and wood frame. This frame is a remnant of a simple crusher that received soil from the conveyor and fed it to the mixing buckets. Soil is present inside a metal grate that is mounted on a wooden deck (Figure 6). All three elements of the feature are resting on their sides and have been damaged. Metal parts have been bent and twisted, and many parts exhibit rust and corrosion. Twisted and bent metal parts on the machine indicate they were likely displaced from their original location and deposited near their present location during construction of the golf course in the early 1990s.

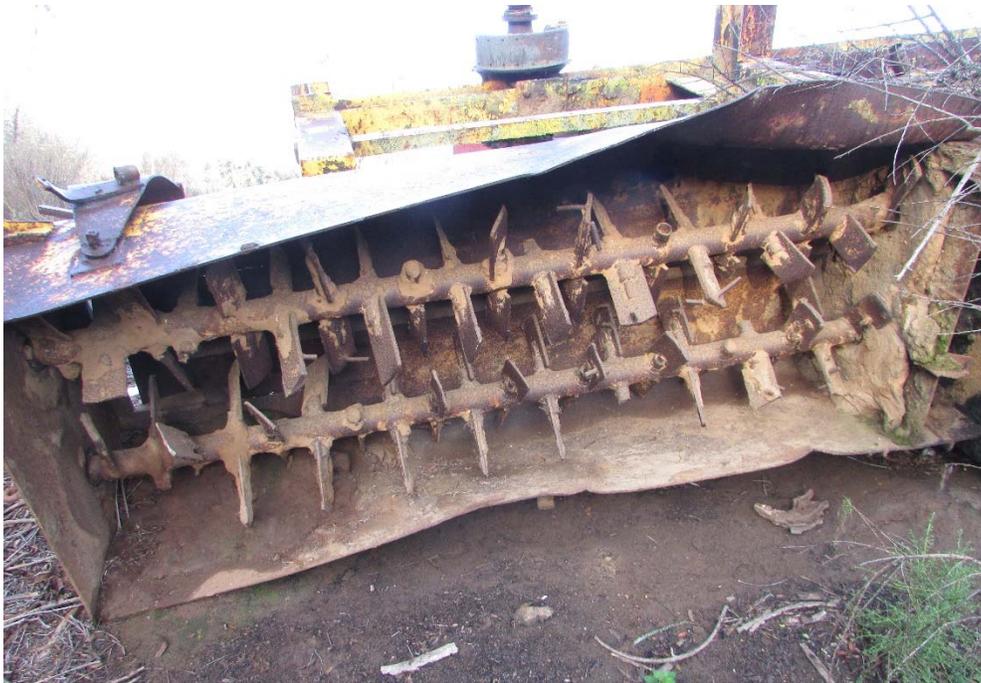
Figure 4. Image of the mixing bucket with paddlewheels.

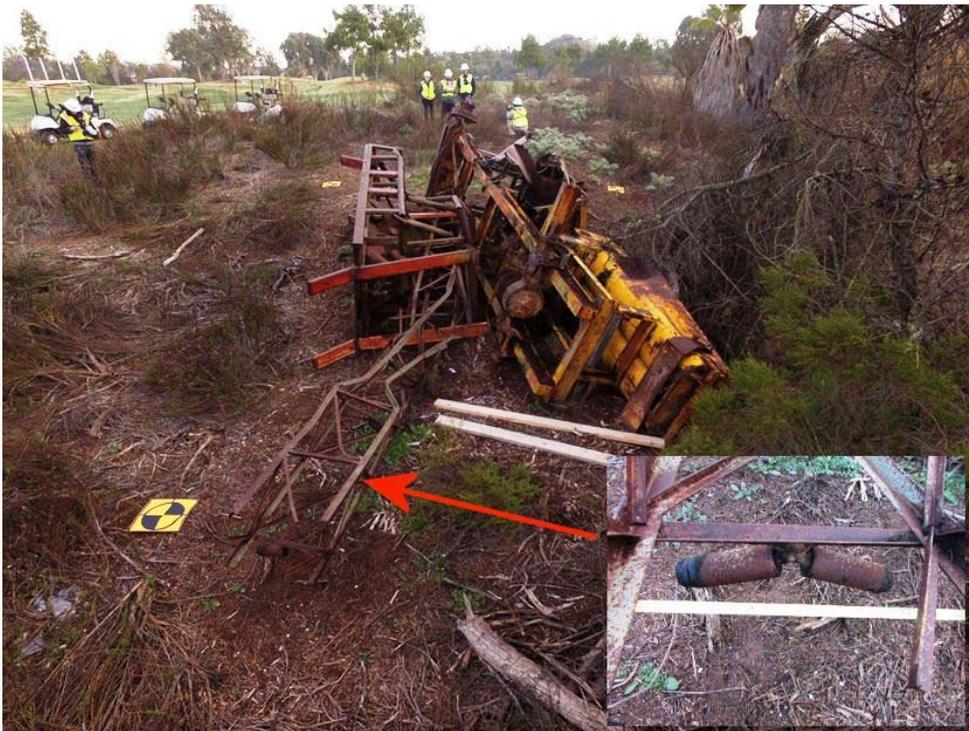
Figure 5. Conveyor belt remnants at Feature 1. Inset shows rollers attached to the metal frame.

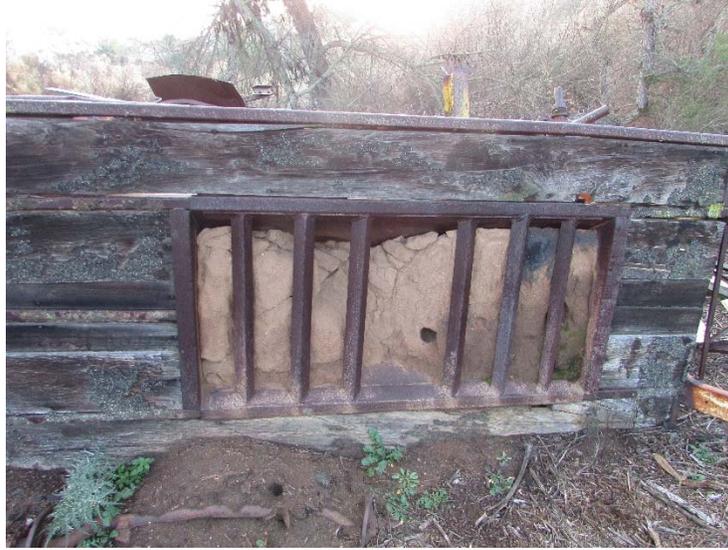
Figure 6. Image shows the wood deck and metal grate at Feature 1. Note soil remnants inside the grate.

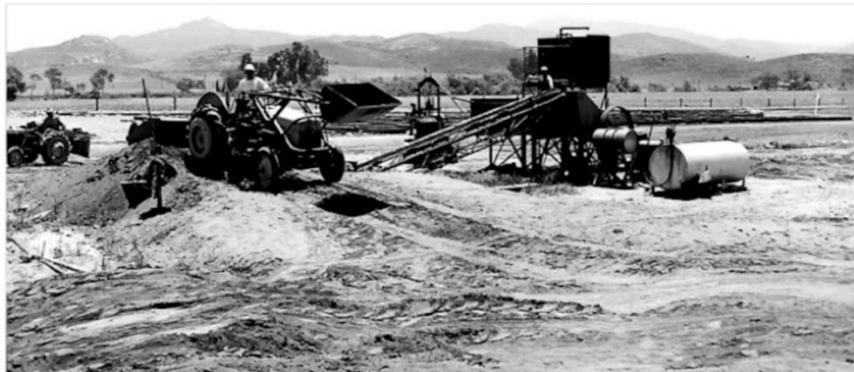
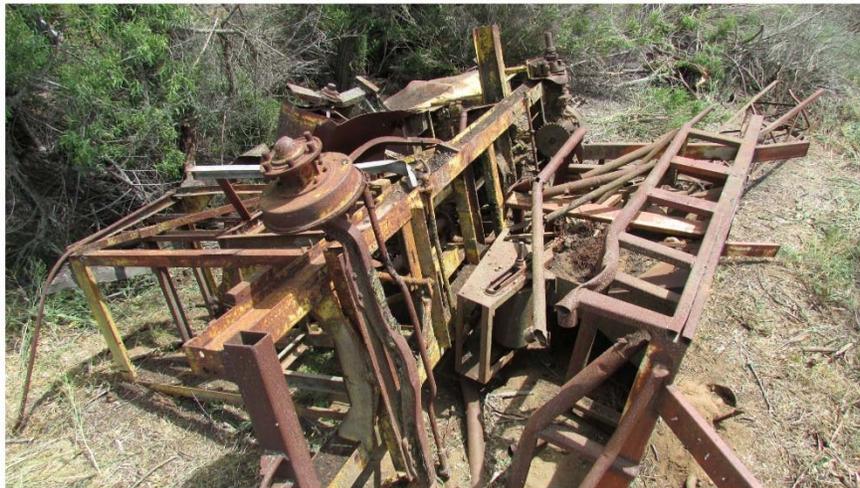
Figure 7. Upper image shows the original Foster and Klieser mixer, lower image shows remnants of mixer mounted on a vehicle chassis at Feature 1.

The Adobe Block Manufacturing Company first operated a Caladobe mixing machine acquired from the Foster and Kleiser Company (San Diego Union 1 May 1949) which appears in historic images of the site (Figure 7). It was small enough to be easily moved, and it used a belt drive and flywheel to turn the mixing paddles. By 1959, the company had replaced the original mixer with a mobile mixer mounted on a wheeled chassis that used gears to turn the paddles.

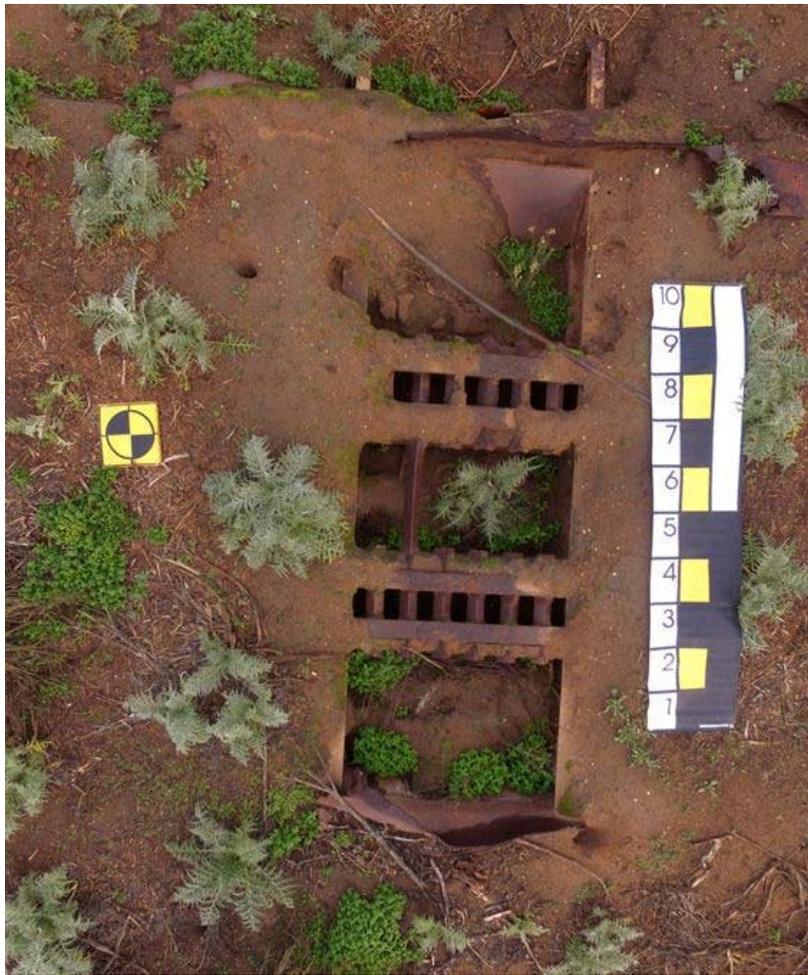
Figure 8. Aerial image of machinery remnants at Feature 2.

Feature 2 is located 60 ft north of Feature 1. It consists of a partly buried metal frame with attached parts, including sheet metal sides, and cross beams set on the frame (Figure 8). Most of the machine is buried, and only a portion of the metal frame is exposed in a 16-x-11-ft area. Pieces of machinery are present on the surface nearby to the east and south. An exposed end of one I beam has a small chain attached. This device may have been used with the conveyor belt and meat frame at Feature 1. Modern day adobe maker John Morris, owner of the San Tan Adobe Company, Queen Creek Arizona, claims this device was placed into a pit, and the metal frame and grate from Feature 1 were placed on top. The soil was passed through the grate, and into the pit, where the conveyor belt carried the soil to the mixing bucket.

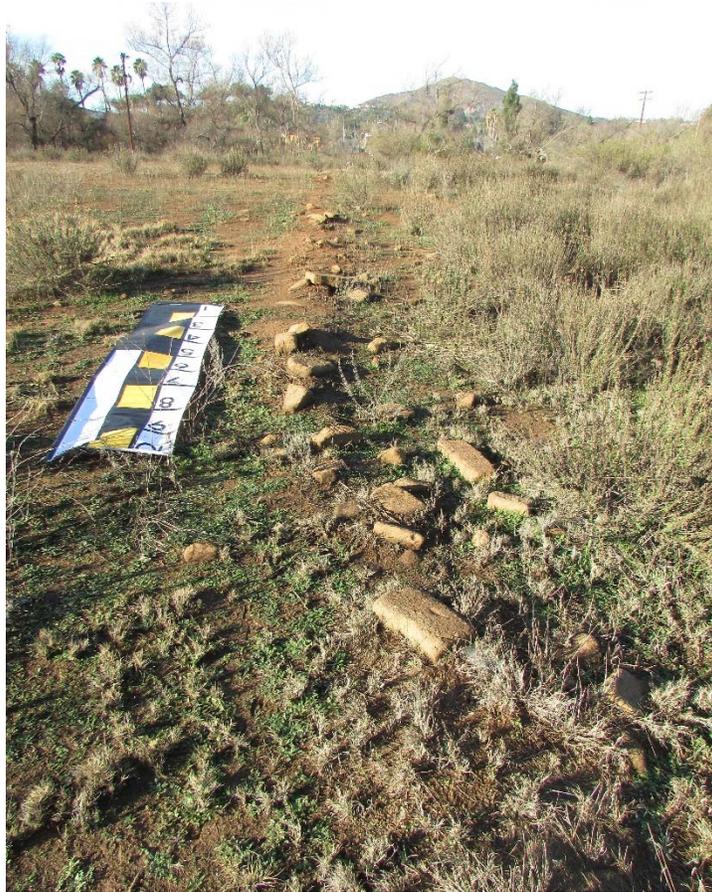
Figure 9. Linear deposit of adobe brick fragments at Locus B.

Features within Locus B include a linear concentration of adobe brick fragments, and other small areas that contain concentrations of adobe brick fragments (Figure 9). The linear concentration is 150 ft long and 3 ft wide, with more than one course visible in some areas. Smaller nonlinear clusters of adobe brick fragments in the area include small 3-ft-diameter clusters and others that are 20 to 30 ft in diameter. These whole bricks and brick fragment concentrations are 1 to 3 ft high.

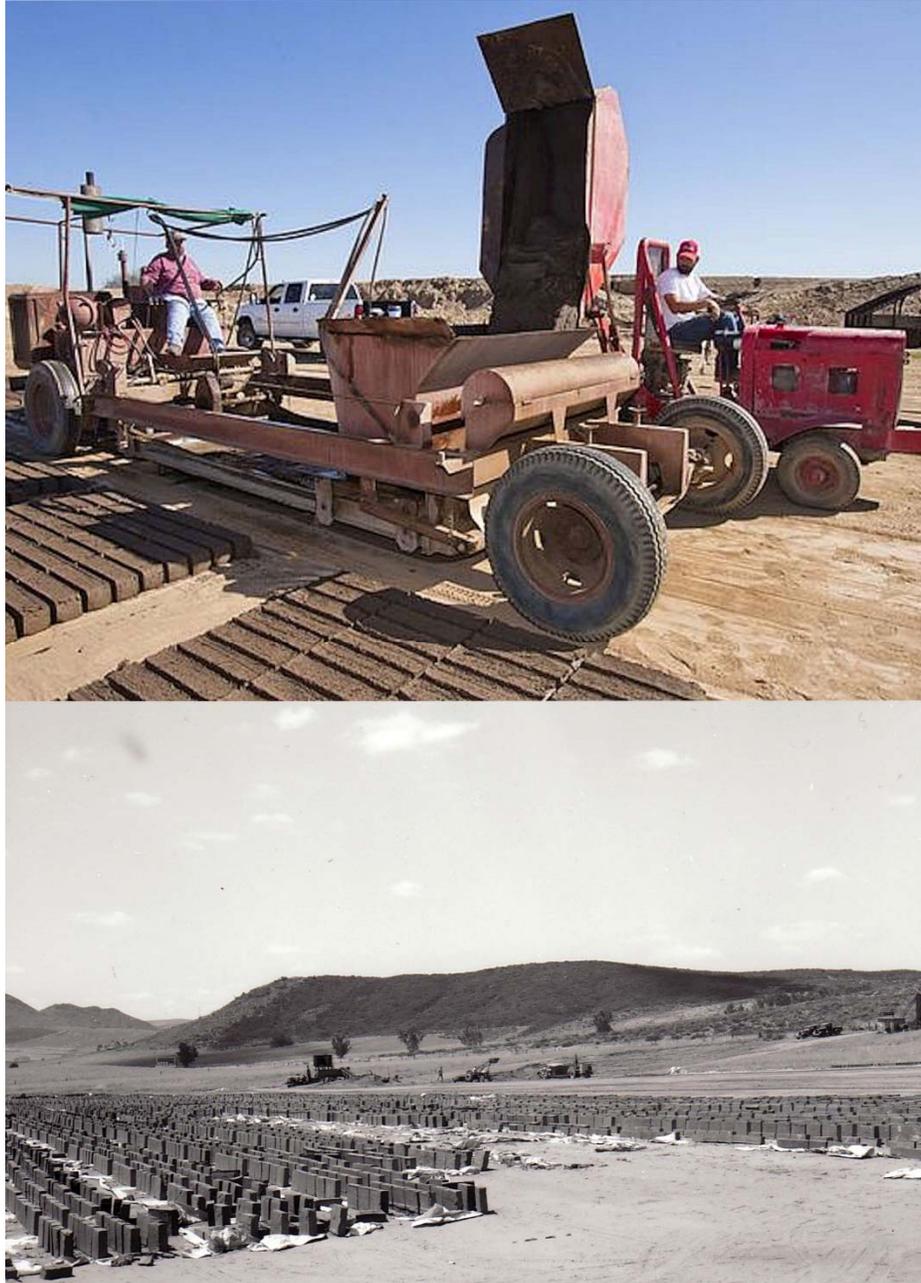
Figure 10. The lay down machine would roll across the site as it formed and set the adobe bricks.

The adobe bricks and brick fragments at Locus B represent debris from the large drying and curing area that was present across much of the site (Figure 10). Long rows of adobe bricks are visible in a 1968 aerial photograph, as well as in images of the older site near Kit Carson Park. These images are consistent with the historical records describing the drying and curing processes involving linear formations. Green's company used a Sumpft lay down machine to form and set the bricks, resulting in the linear concentrations seen in the aerial imagery as well as archaeologically. The Minerals Information Service described how the bricks were set and dried in 1959:

The bricks are molded in a large field adjacent to the plant. This operator [Hans Sumpft] has developed a special mold in-machine, mounted on wheels, which molds 35 4" x 7-z" x 16" bricks at one time. It consists of a steel mold mounted so that it can be raised and lowered, and a moveable hopper to feed mud into the compartments of the mold. Two men operate the machine, which moves in straight lines over the smoothly scraped surface of the drying field. A strip of paper unrolls on the ground beneath the machine, the bottomless mold is lowered onto the paper, and the adobe mix is fed into the mold from the hopper. The scrapers level the top of the mud, and the mold is immediately raised, leaving the bricks on the paper. Then the whole machine is moved forward, the mold washed with a water spray, and lowered for the next filling. The hopper 'trucks' shuttle between mixer and molding machine as the bricks are laid out in long rows. Different molds for the various sizes and shapes of bricks can be mounted in the molding machine. This operator holds a patent on these machines and has several which he makes available on a rental basis [Minerals Information Service 1959:4-5].

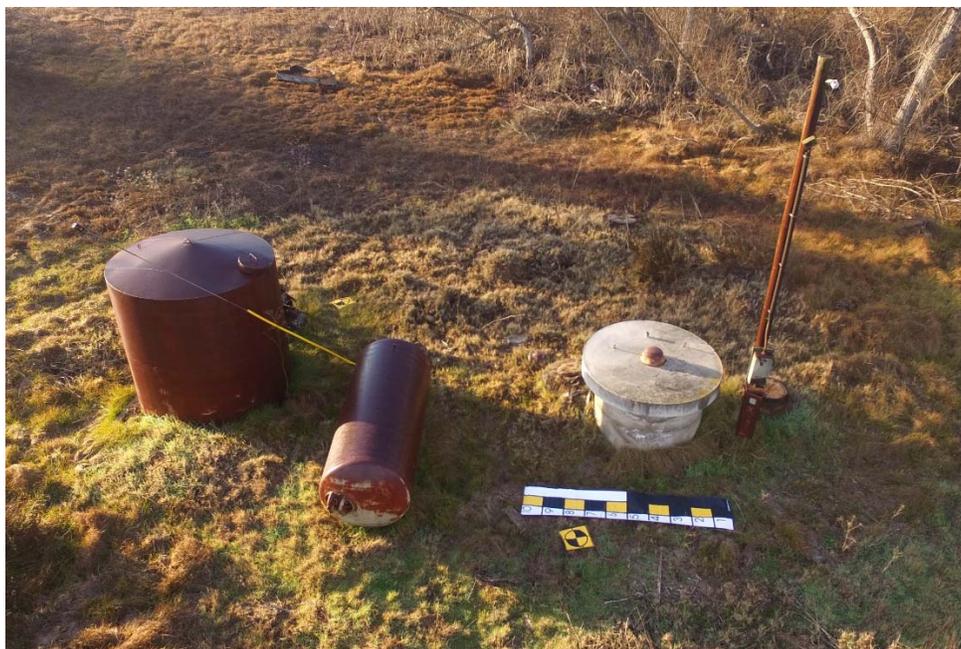
Figure 11. Aerial image of Locus C.

Features at Locus C consist of a wooden power pole, a concrete water well, and water tanks (Figure 11). The wood power pole is 6 1/2 in. in diameter, and has been treated with coal oil creosote. Three date nails are affixed to the pole. Nail heads exhibit marks indicating the years 1941, 1945, and 1956. A circular concrete well head with a galvanized metal vent is present near the power pole, with a large 8 x 8 ft metal water storage tank located on the north. The large tank is set within a wood frame filled with gravel. A second smaller tank measuring 11 ft high and 4 ft in diameter is also present. A small wooden pump house measuring 3 ft and 8 in high with a corrugated metal roof is also located near the well. Electric motor and pump remnants are also present near the well. The concrete well is capped with a concrete lid made of modern concrete. The circular well is made of older concrete that contains larger sand grains and small rounded rock aggregate.
